Manhole Inspection Summary

Manhole # S47KK_018MH

Insp Date: **5/5/08 1:53 PM**

Location Address: **Lanvale St**

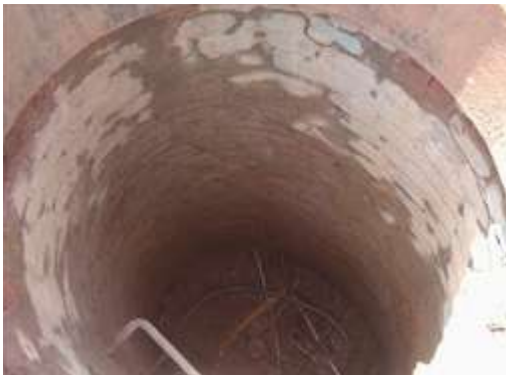
Defect 1

Infiltration

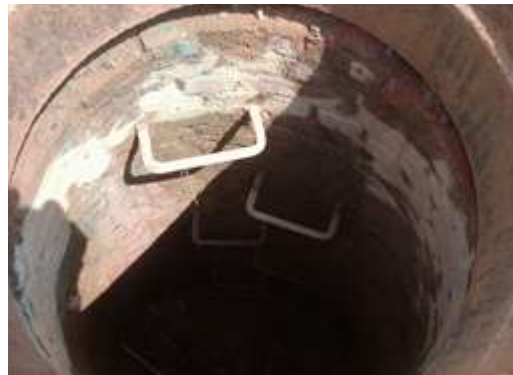
Defect 2

Frame Leaks

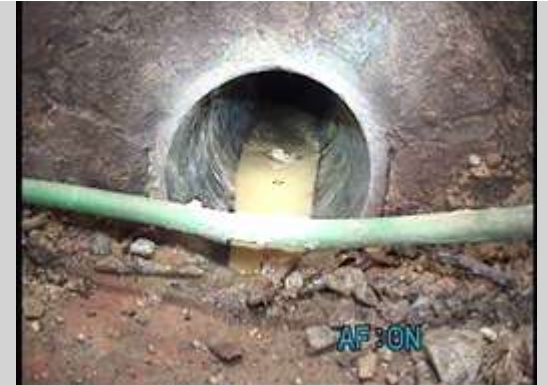
12 O'Clock Outflow

8 in. Circular Gravity Sewer
Pipe Out @ 12 O'Clock

Deposits: ☐ None ☒ **Mud** ☐ Sludge ☒ **Debris** ☐ Grease

Silt Depth: **2** (in.) Deposits Extent: **Light**
